ENGINEERING REPORT
RED LIGHT RUNNING TRAFFIC MONITORING
SYSTEM

State Route 509/ Marine View Dr. S at 7th Pl. S
Des Moines, WA

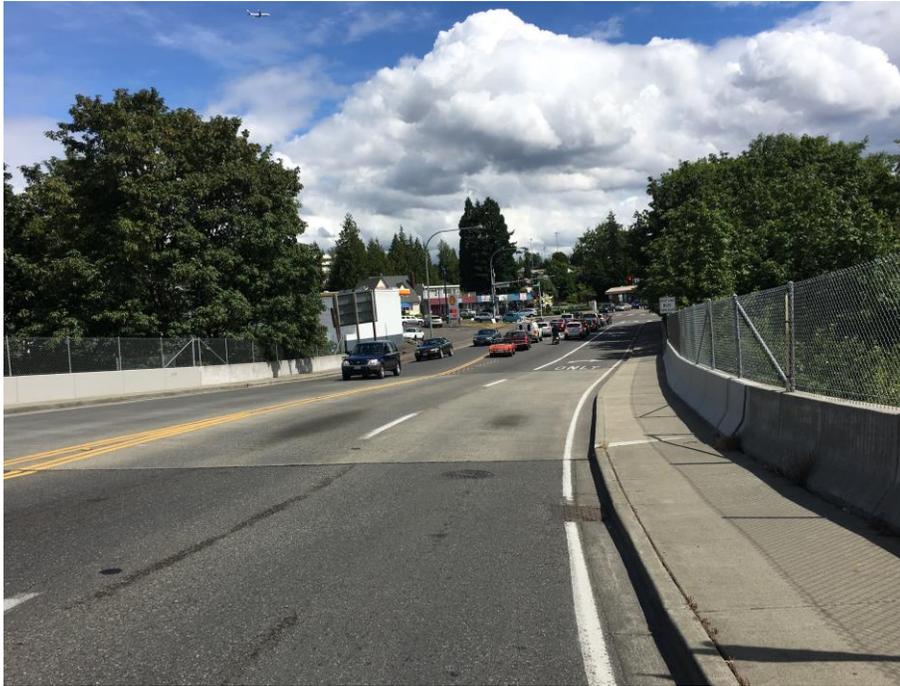
Figure 2: Southbound approach, looking south

D. Evaluation of Traffic Signal Visibility
